dsPIC33EPXXXGM3XX/6XX/7XX Family Silicon Errata and Data Sheet Clarification

The dsPIC33EPXXXGM3XX/6XX/7XX family devices that you have received conform functionally to the current Device Data Sheet (DS70000689D), except for the anomalies described in this document.

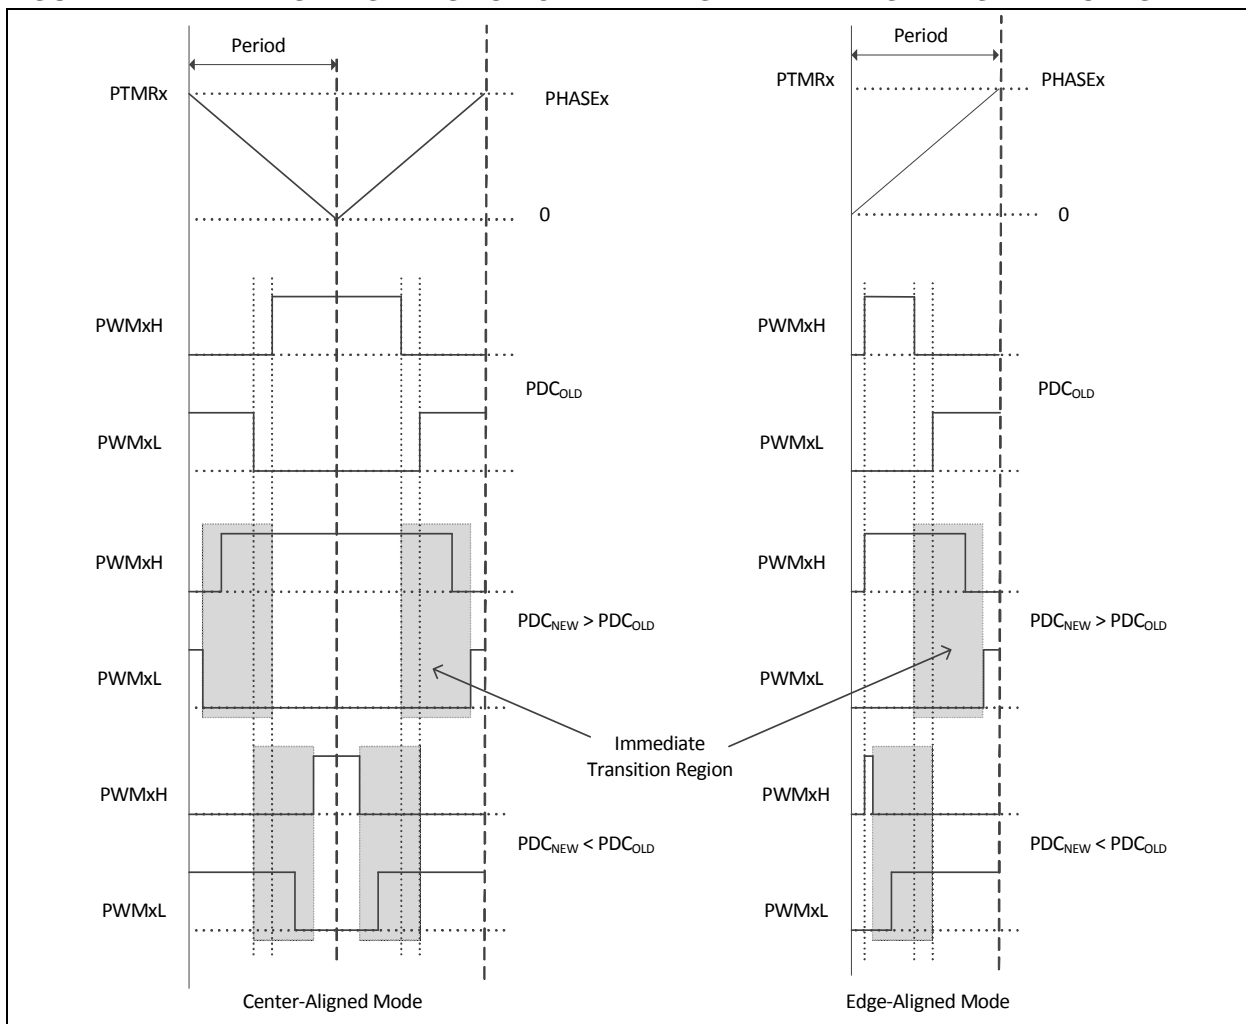
FIGURE 1: TIMING DIAGRAMS FOR CENTER-ALIGNED AND EDGE-ALIGNED MODES

The PWM generator may not assert dead time on the edges of transitions. This has been observed when all of the following conditions are present:

- The PWM generator is configured to operate in Complementary mode with Independent Time Base (ITB) or master time base;
- Immediate update is enabled; and
- The value in the PDC register is updated in such a manner that the PWMxH and PWMxL outputs make an immediate transition.

time base, will determine if the PWMxH and PWMxL outputs make an immediate transition. PWMxH and PWMxL outputs make an immediate transition if the Duty Cycle register is written with a new value, PDC_{NEW}, at a point of time when the PWM time base is counting a value that is in between PDC_{NEW} and PDC_{OLD}. Additionally, writing to the Duty Cycle register, close to the instant of time where dead time is being applied, may result in a reduced dead time which is effective on the PWMxH and PWMxL transition edges.

In **Figure 1**, if the duty cycle write occurred in the shaded box, then PWMxH and PWMxL will make an immediate transition without dead time.

In most applications, the duty cycle update timing can be controlled using the TRIGx trigger, or Special Event Trigger, such that the above mentioned conditions are avoided altogether.

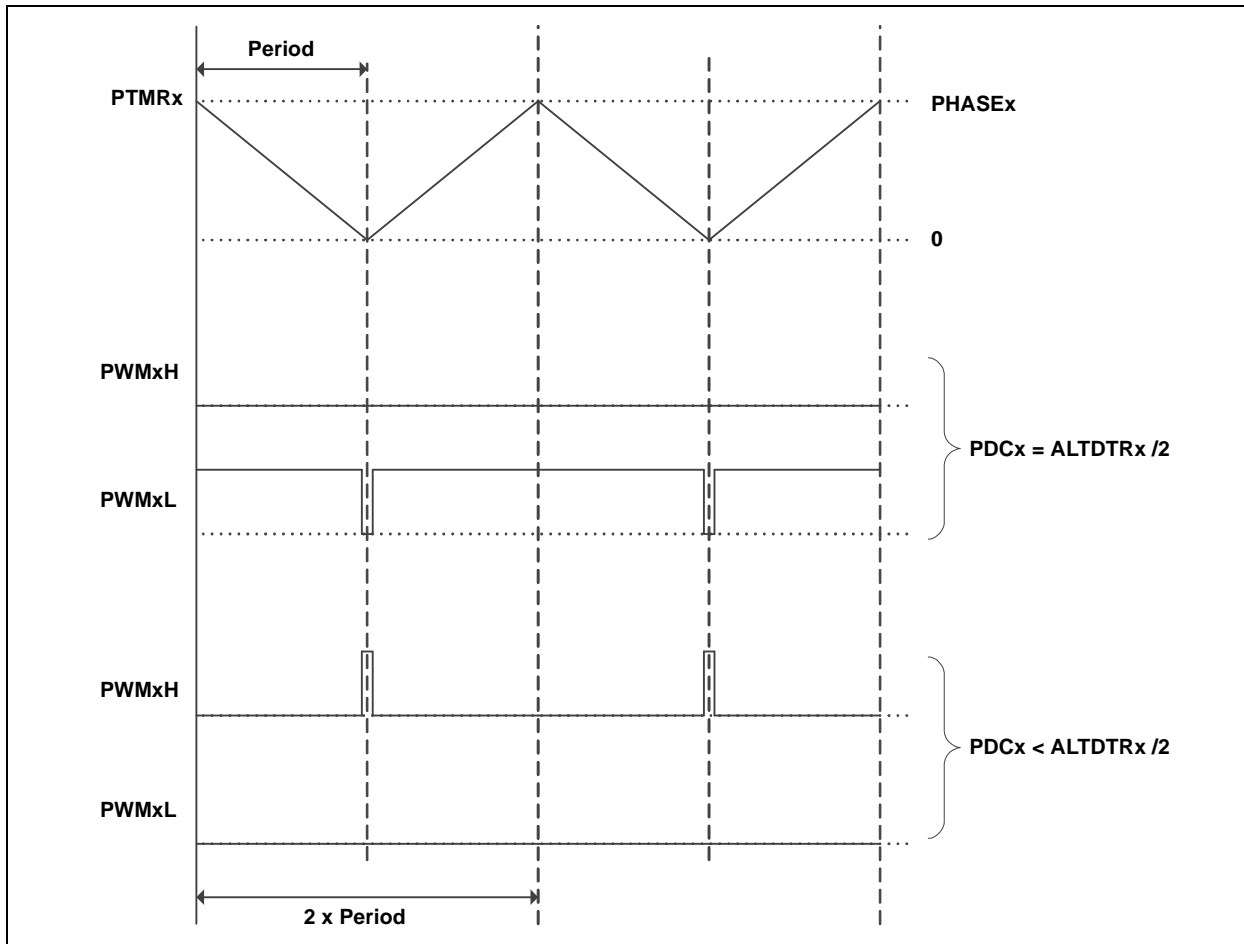
FIGURE 2: PWM GENERATOR TIMING DIAGRAM

In Center-Aligned Complementary mode with Independent Time Base, if the value in the PDCx register is less than one-half the value in the ALTDTRx register, the PWM generator will force the PWMxL to low, and on the PWMxH, generates pulses of a width less than twice the dead time, as shown in Figure 2.

Include a software routine to ensure that the duty cycle value written to the PDCx register is at least one-half of the value in ALTDTRx. Example 1 shows one method, with PDCtemp representing the variable which has the value to be written to the PDCx register. Alternatively, for duty cycle values less than half the desired dead-time value, zero out the ALTDTRx register or dynamically reduce the value in the ALTDTRx register, such that ALTDTRx is always equal to $2 * PDCx$, as shown in Example 2.

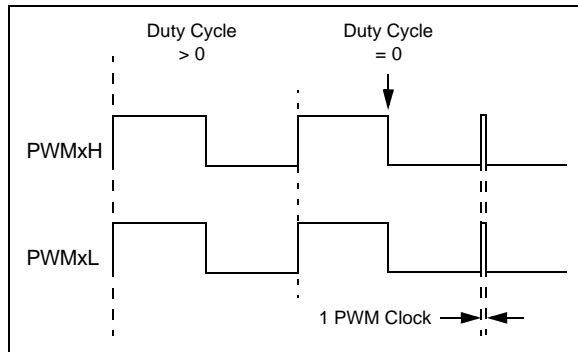
FIGURE 3:

In certain output modes, the PWMx module produces a pulse glitch of one PWM clock in width (Figure 3). This has been observed only when all of the following are true:

- Either Redundant or Push-Pull Output mode is selected ($\text{IOCONx}\langle 11:10 \rangle = 10$ or 01);
- Immediate Update is disabled ($\text{PWMCONx}\langle 0 \rangle = 0$); and
- The value of the current Duty Cycle register (either the PDCx or MDC register, as determined by $\text{PWMCONx}\langle 8 \rangle$) is updated to zero from any non-zero value.

The pulse glitch has been observed to occur at the beginning of the following PWM boundary period.

If the application requires a duty cycle of zero, two possible work arounds are available.

1. Use the PWM overrides to force the output to a low state, instead of writing a '0' to the Duty Cycle register. When using this method, the PWM override must be disabled when the duty cycle is a non-zero value. If output override synchronization is configured to occur on CPU clock boundaries ($\text{IOCONx}\langle 0 \rangle = 0$), enabling and disabling the override must be timed to occur as closely as possible to the PWM period boundary.
2. Configure the module for Immediate Update ($\text{PWMCONx}\langle 0 \rangle = 1$) before enabling the module. In this mode, writes to the Duty Cycle register have an immediate effect on the output. As with the previous work around, writes to the Duty Cycle register must be timed to occur as close to the PWM period boundary as possible in order to avoid distortion of the output.

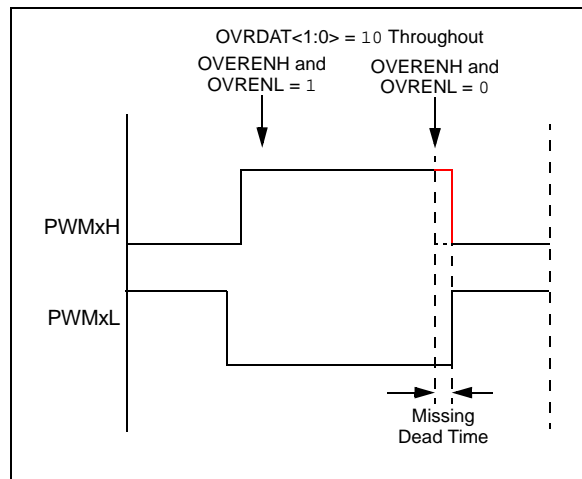
FIGURE 4:

In Complementary Output mode, the expected dead time between transitions of the PWMxH and PWMxL outputs may not be asserted when the following occurs:

- Output override synchronization is configured to occur on the CPU clock boundary ($\text{IOCONx}\langle 0 \rangle = 0$);
- Both PWMxH and PWMxL overrides are enabled prior to the event (OVRENH and OVRENL are both '1'), and
- Both overrides are disabled (OVRENH and OVRENL are both '0') at the instant the dead time should be asserted (Figure 4).

This has been observed in both Center-Aligned and Edge-Aligned modes.

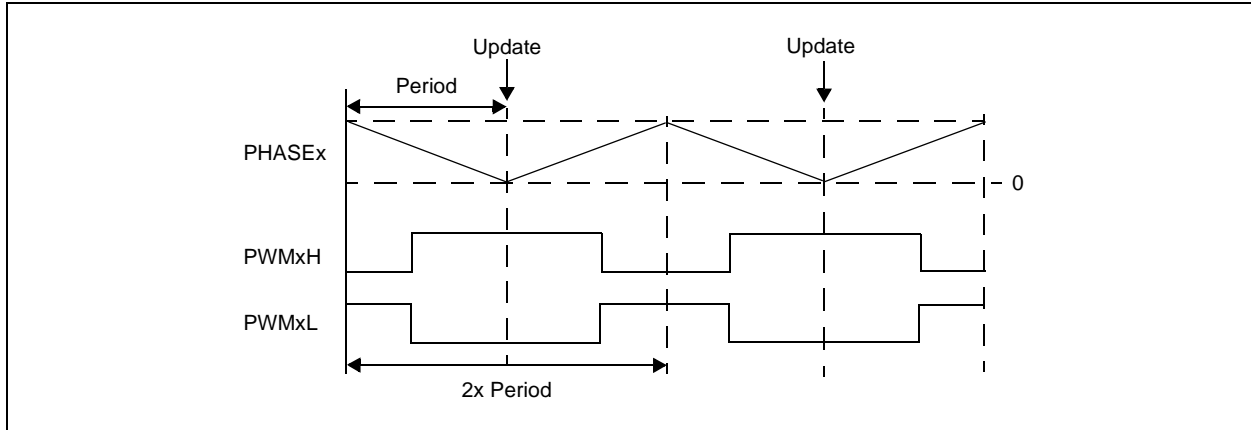
FIGURE 5:

In Center-Aligned Complementary mode with Independent Time Base, updates to the PHASEx register take effect in the middle of a Center-Aligned PWM cycle, as shown in Figure 5. This occurs only when the Immediate Update feature is disabled (IUE = 0). If Immediate Update is enabled (IUE = 1), the PHASEx register updates will take effect immediately.

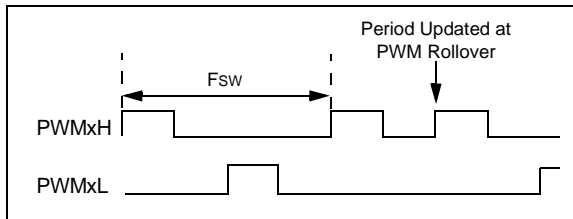
FIGURE 6:

When the PWM module is configured for Push-Pull mode (IOCONx<11:10> = 10) with the Enable Immediate Period Update bit enabled (PTCON <10> = 1), a write to the Period register that coincides with the period rollover event may cause the push-pull output logic to produce back-to-back pulses on the PWMx pins (Figure 6).

Ensure that the update to the PWM Period register occurs away from the PWM rollover event by setting the EIPU bit (PTCON<10> = 1). Use either the PWM Special Event Trigger (SEVTCMP) or the PWM Primary Trigger (TRIGx) to generate a PWM Interrupt Service Routine (ISR) near the start of the PWM cycle. This ISR will ensure that period writes do not occur near the PWM period rollover event.
